RETAILER SAVES ON CONCRETE MEZZANINE REPAIR ◆ A RESINDEK® SUCCESS STORY

RETAILER OF APPAREL AND HOME FASHIONS HAD A SEVERELY DAMAGED 75,000 SF. CONCRETE MEZZANINE FLOOR AT THEIR DISTRIBUTION CENTER

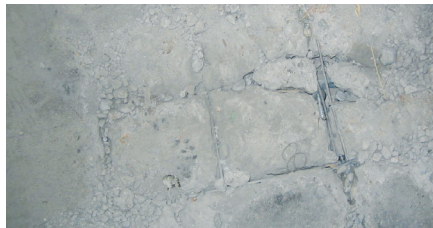
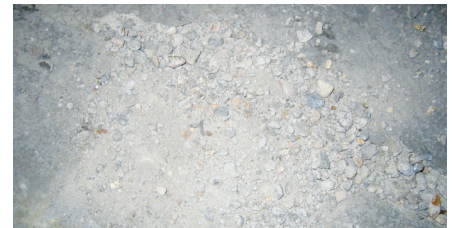
"We introduced pallet jacks to the mezzanine floor and it was just too much weight and deflection. As a result, the pallet jacks broke through the concrete mezzanine flooring in 3 different places and cracked the mezzanine concrete floor in numerous areas. We had a real mess on our hands." - Retailer's Project Engineer

Concrete mezzanine flooring with significant damage prior to ResinDek.

Daigle Engineers, Inc. contacted Cornerstone Specialty Wood Products, LLC with their money saving solution. By placing steel sleepers on the damaged concrete and directly over the steel bar joists below, the loads could be transferred through the cracked concrete directly onto the substructure. By installing the steel sleepers and ResinDek® Xspan® over the existing slab, it would avoid flexural loading of the damaged slab and deck.

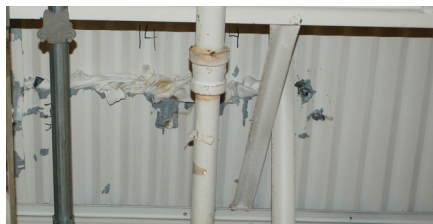
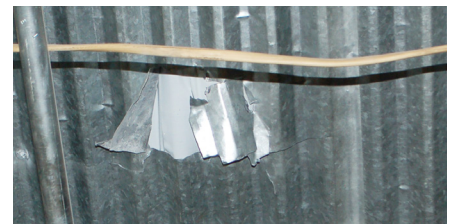
Attempted repairs beneath the mezzanine to block debris from falling through.

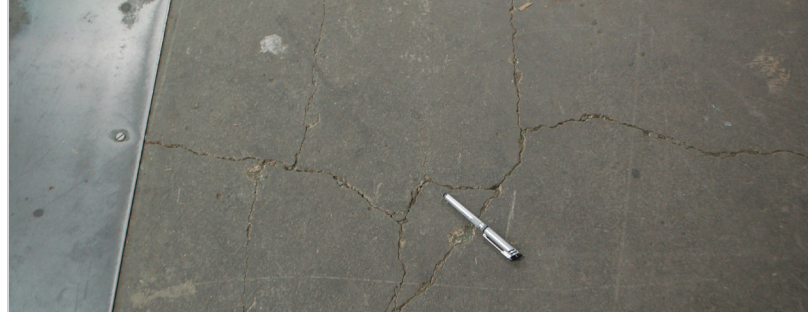
Prior to ResinDek repair, steel plates had to be attached on top of the concrete mezzanine floor so pallet truck wheels could continue to roll.

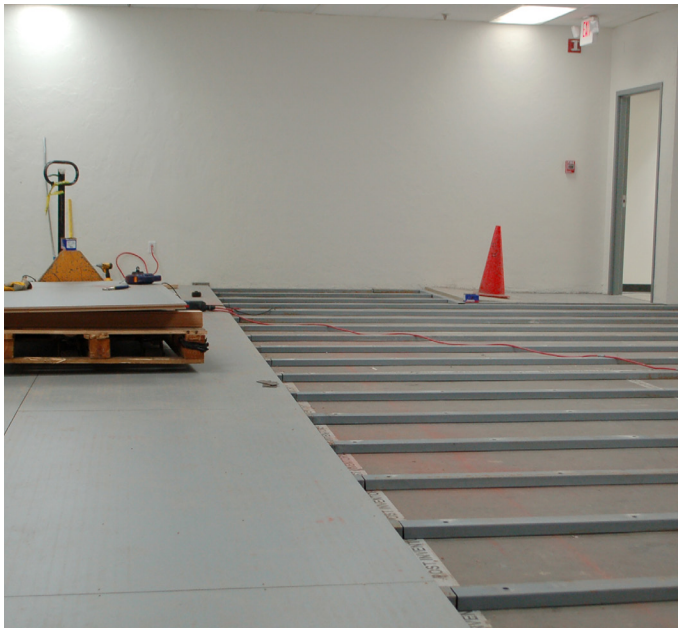
Installation of ResinDek and steel sleepers over damaged concrete.

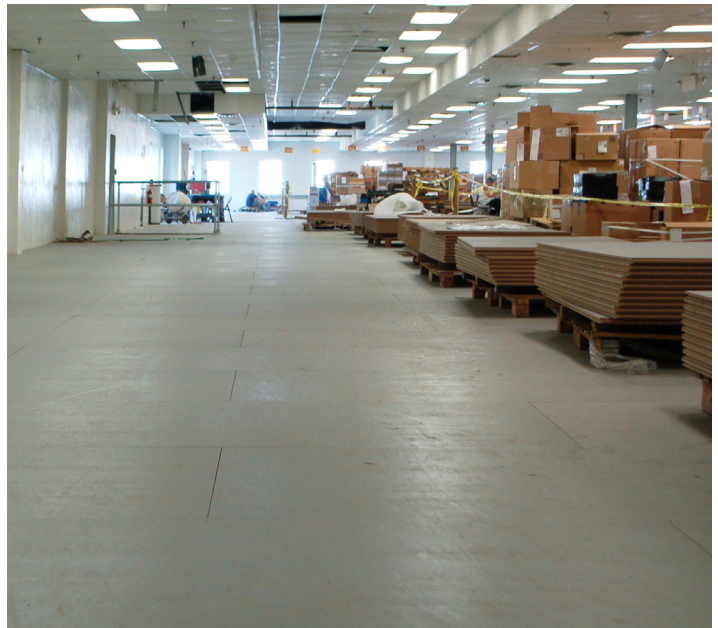
ResinDek installed and loads moving easily.
