Retailer Saves on Concrete Mezzanine Repair

Retailer of Apparel and Home Fashions had a severely damaged 7,000 square meter concrete mezzanine floor at their distribution center.

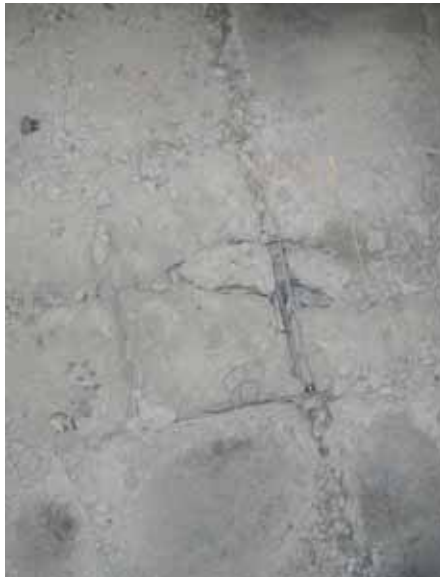
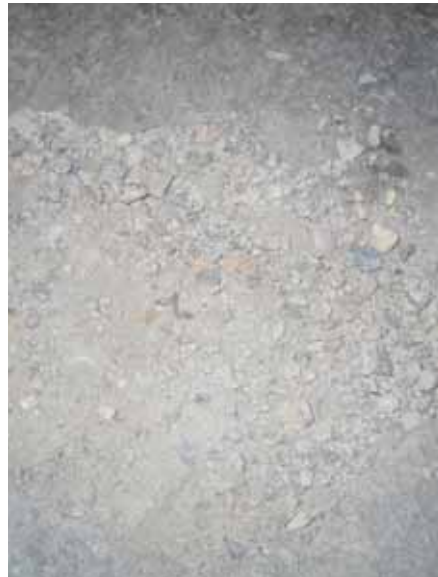
“We introduced pallet jacks to the mezzanine floor and it was just too much weight and deflection. As a result, the pallet trucks broke through the concrete mezzanine flooring in 3 different places and cracked the mezzanine concrete floor in numerous areas. We had a real mess on our hands.”

Concrete mezzanine flooring with significant damage prior to ResinDek

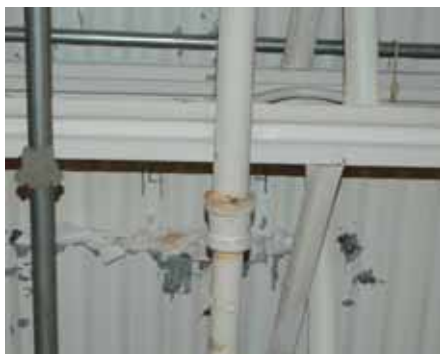
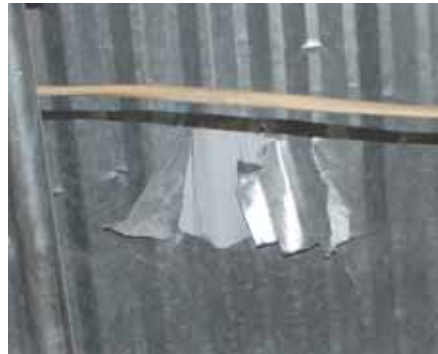
Attempted repairs beneath the mezzanine to block debris from falling through

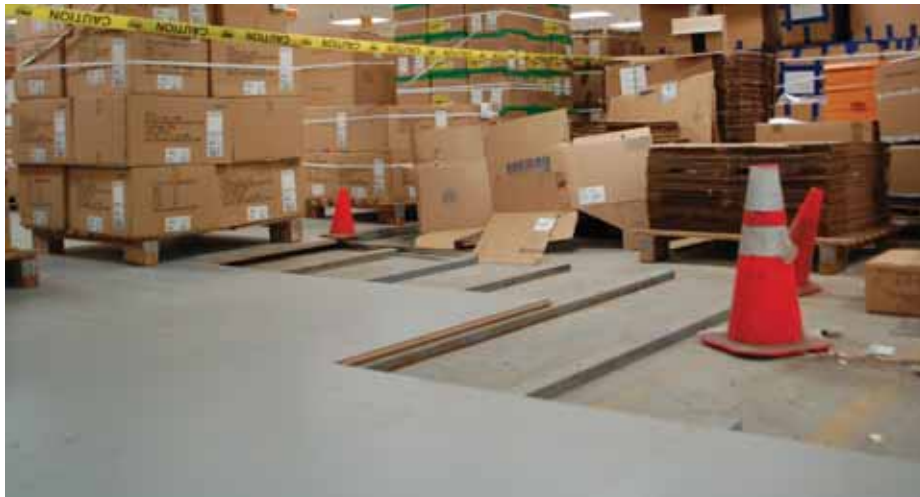
Installation of ResinDek and steel sleepers over damaged concrete

Daigle Engineers, Inc. contacted Cornerstone Specialty Wood Products, LLC with their money saving solution. By placing steel sleepers on the damaged concrete and directly over the steel bar joists below, the loads could be transferred through the cracked concrete directly onto the sub-structure. By installing the steel sleepers and ResinDek® Xspan® over the existing slab, it would avoid flexural loading of the damaged slab and deck.

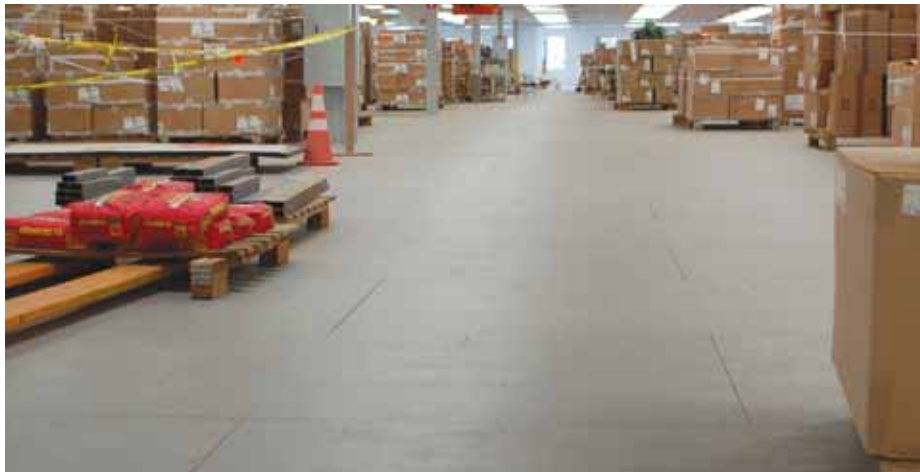
New ResinDek® panels installed

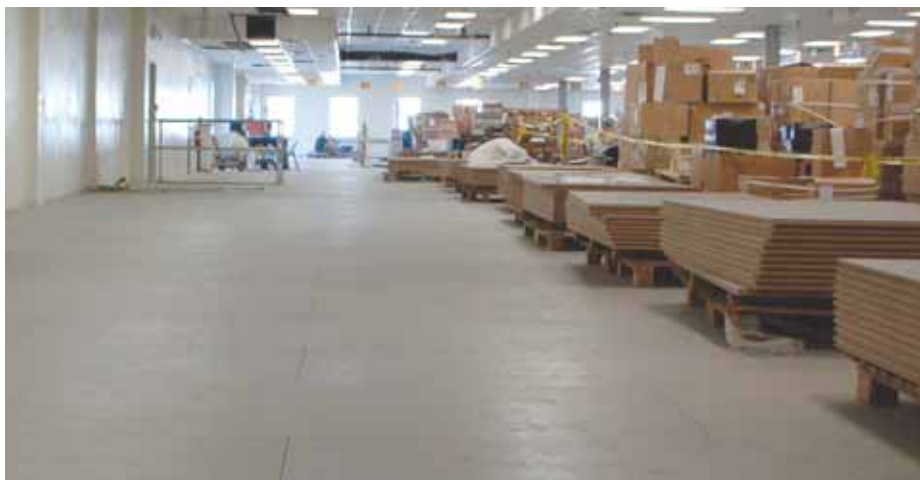
ResinDek installed and loads moving easily
